Manhole Inspection Summary

Manhole # S35S__012MH

Insp Date: 1/30/08 10:40 AM

Location Address: **e.clement st**

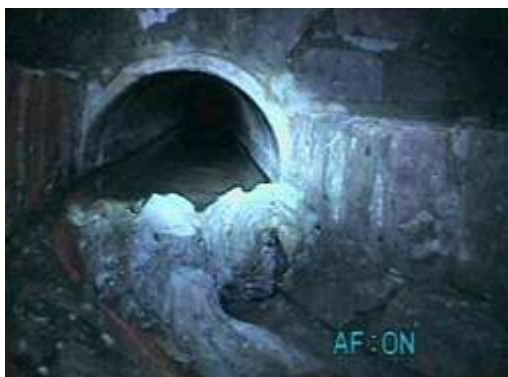
Defect 2

Condition: ☐ Sound ☐ Cracked ☐ Root Intrusion ☐ Deteriorated ☐ Leaks ☒ **Debris**

channel debris

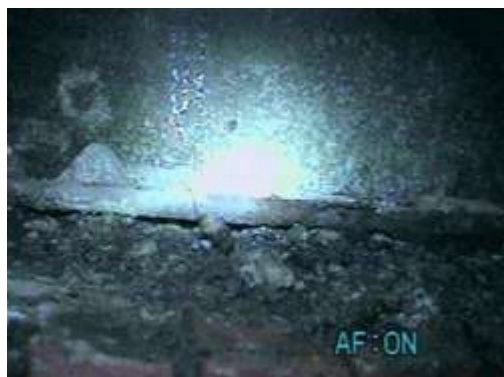
Defect 1

Condition: ☐ Sound ☐ Cracked ☐ Root Intrusion ☐ Deteriorated ☐ Leaks ☒ **Debris**

bench debris

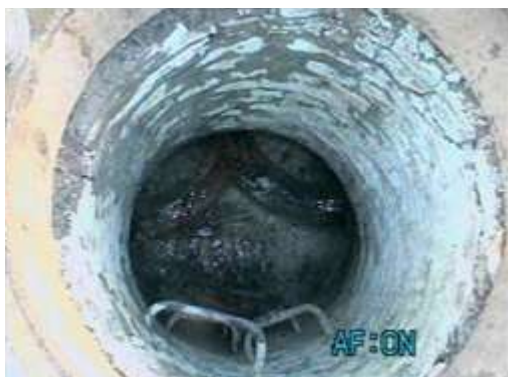
Defect 3

Infiltration: ☐ None ☐ Joint ☐ Cracks ☐ Mortar ☐ Roots ☒ **Wall**

Steps Count: **5** Missing: **0** ☒ **Corroded**

Offset, Corbel Infiltration & chimney loose bricks, Corroded Steps

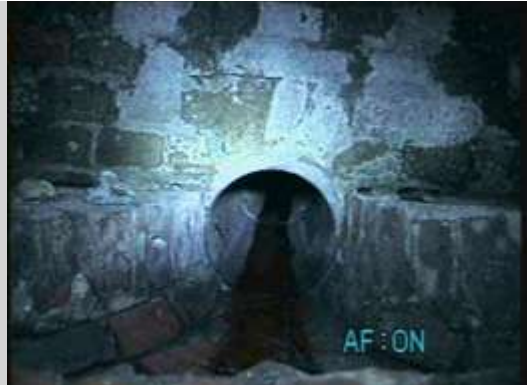
12 O'Clock Outflow

8 in. Circular Gravity Sewer
Pipe Out @ 12 O'Clock

Invert Depth: **9.70** (ft.) Flow Characteristics: **Fast**

Deposits: ☒ None ☐ Mud ☐ Sludge ☐ Debris ☐ Grease

Infiltration: **None** Pipe Seal Cond: **Unknown**

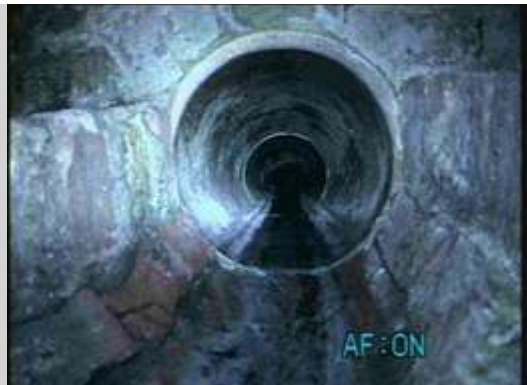
3 O'Clock Inflow

8 in. Circular Gravity Sewer
Pipe In @ 3 O'Clock

Invert Depth: **9.30** (ft.) Flow Characteristics: **Fast**

Deposits: ☒ None ☐ Mud ☐ Sludge ☐ Debris ☐ Grease

Infiltration: **None** Pipe Seal Cond: **Unknown**

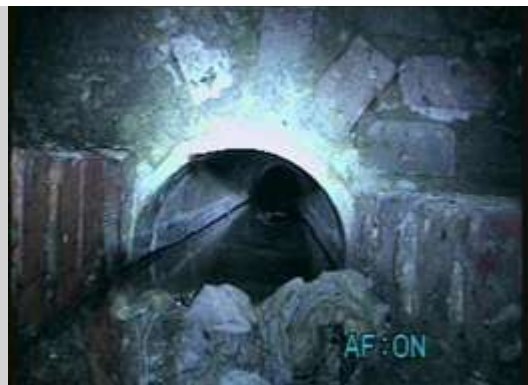
9 O'Clock Inflow

8 in. Circular Gravity Sewer
Pipe In @ 9 O'Clock

Invert Depth: **9.40** (ft.) Flow Characteristics: **Fast**

Deposits: ☒ None ☐ Mud ☐ Sludge ☐ Debris ☐ Grease

Infiltration: **None** Pipe Seal Cond: **Unknown**
